Originally published in: NuklearForum Schweiz, Materialprüfung mechanischer Komponenten in Kernkraftwerken, November 2009

2.1 E.ON REACTOR PRESSURE VESSEL NOZZLE INSPECTION ISSUE

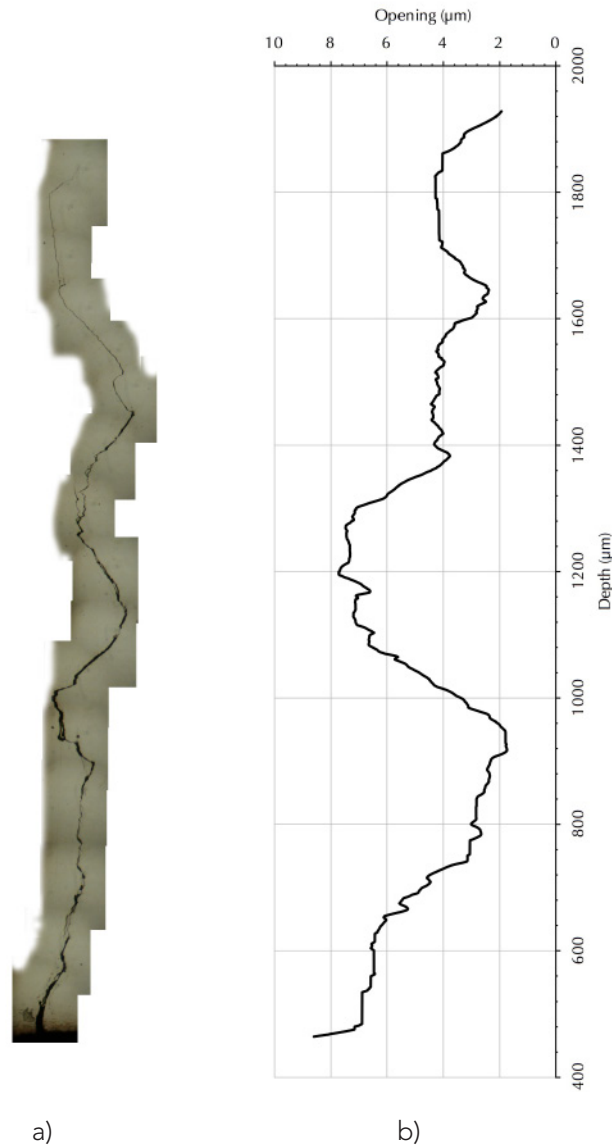
Figure 1
Crack opening profile in depth direction together with the measured opening profile.
