FORTUM STEAM COLLECTOR

Originally published in: Insight Vol 51 No 5 May 2009

3.2 FORTUM STEAM COLLECTOR PRIMARY COLLECTOR

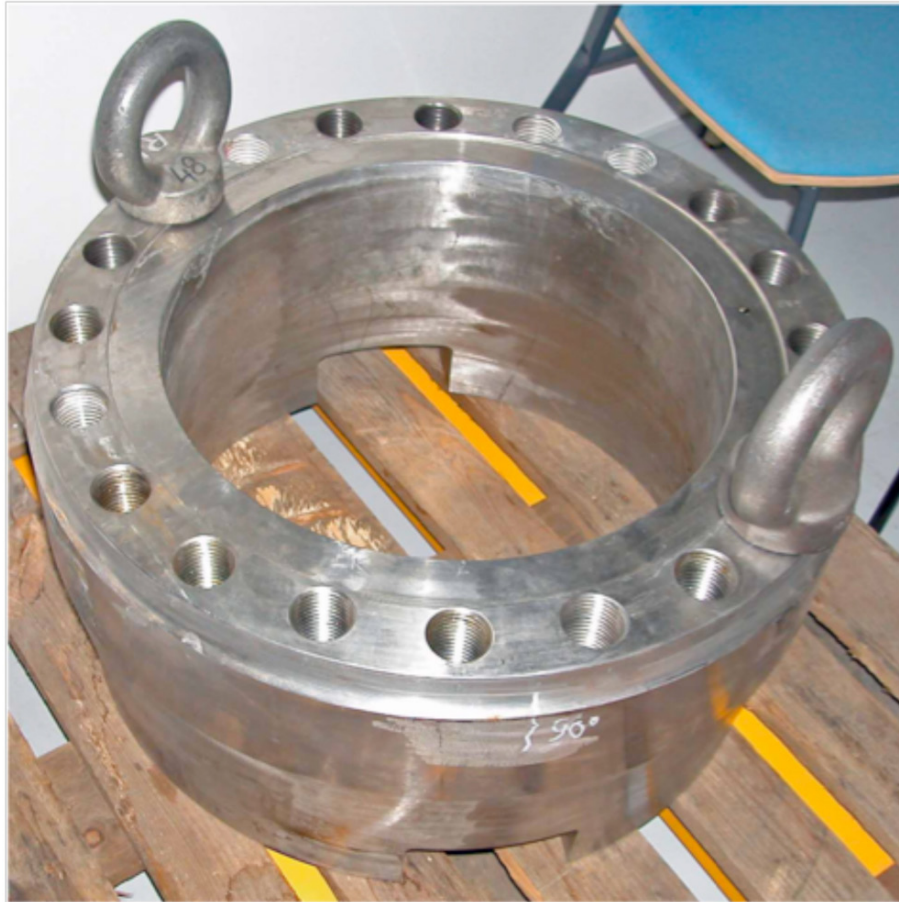
Figure 2
Loviisa test block from vintage material.

The area of interest is cracking in M48x5 threaded holes of the primary collector flange. The inspection is done using phased array UT with scanning from top and inner diameter (ID) surface of primary collector. It was decided to use component removed from a similar powerplant, that never went to operation as a test block for the qualification. Figure 4. shows the qualification test block. The flaw types to be detected are shown in Figure 5.
