ROLLS-ROYCE PLC SEAL FIN

Originally published in: Insight Vol 51 No 5 May 2009

3.2 ROLLS-ROYCE PLC SEAL FIN SAMPLE

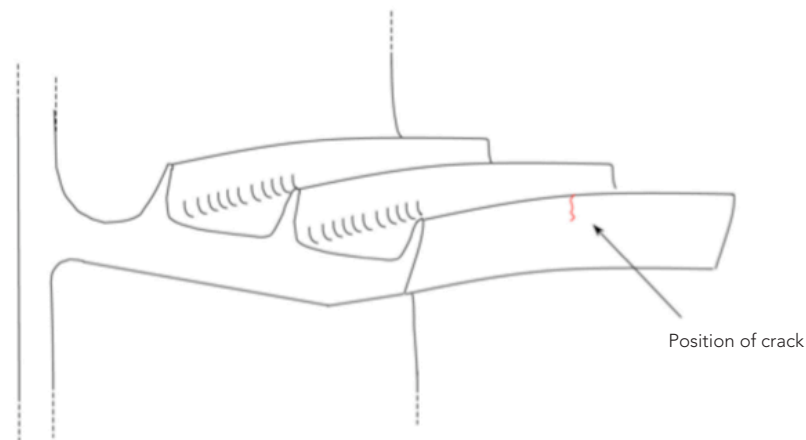
Figure 1
Schematic image of the seal fin sample.

Rolls-Royce plc wished to study the effectiveness of novel NDT methods in detecting cracks under conductive coatings and needed a sample with a known crack population. The component chosen for this work was the seal fin region of a turbine disc. In use this component is covered with a wear coating. The task was to create a realistic test piece containing cracks under the coating and by using the Trueflaw method the cracks could be placed in the required position at the tips of the fin. Figure 1. shows a schematic illustration of the seal fin sample.

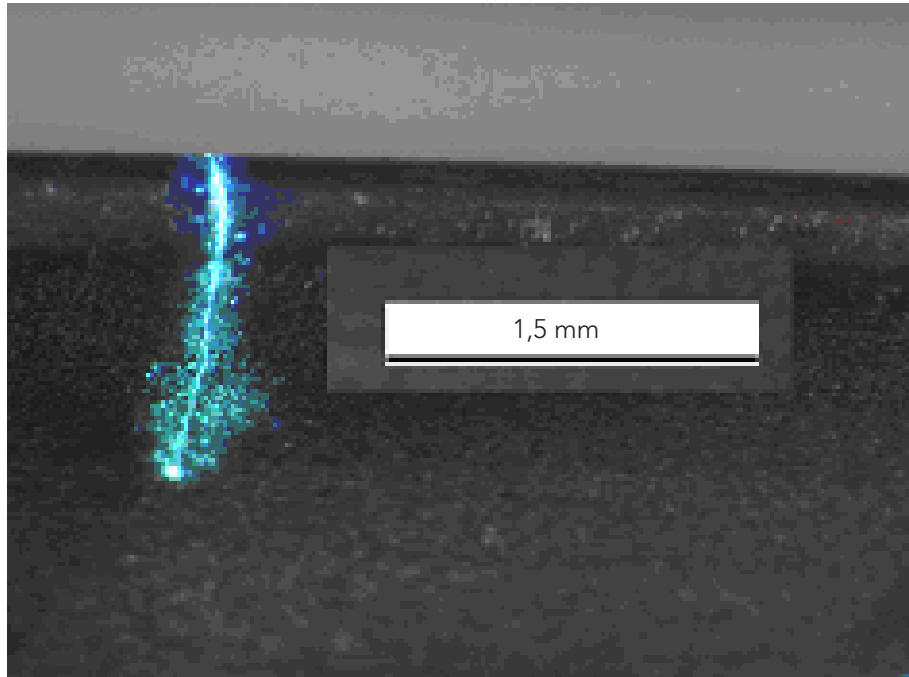
Figure 2
PT indication of seal fin crack.

Numerous cracks were produced at different locations on the seal fin sample to allow determination of inspection capabilities in all interesting locations. A sample penetrant test (PT) image from a crack produced to the fin sample is shown in Figure 2.

Characterisation was done by using penetrant testing with magnified digital imaging to measure the crack size and the crack opening. Some uncoated NDT (Thermosonics) was carried out prior to the coating was applied. Following verification of the cracks using fluorescent penetrant the part was coated and a sample crack cut out. X-ray computer tomography was used to visualise the crack under the coating to verify the coating material had not entered the crack. This can be seen in Figure 3a, showing the coated fin. Figure 3b shows the x-ray image with the tip of the fin removed making the crack beneath clearly visible. This sample is now being used in a series of trials to establish if an inspection method is possible.

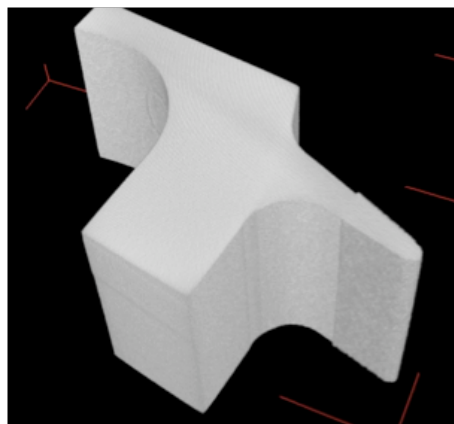
Figure 3a
X-ray image of seal fin showing coating is uncracked.

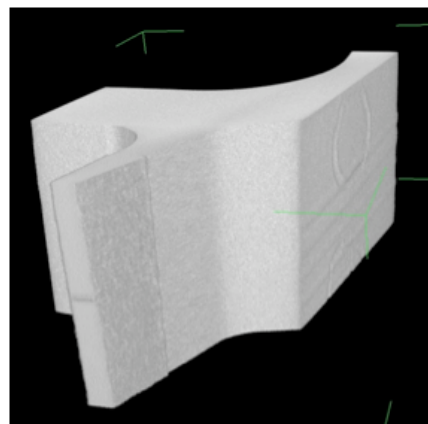
Figure 3b
Seal fin tip removed from x-ray image showing subsurface crack.
